Repair & Strengthening

DYWIDAG Monostrand Repair Methods Save Parking Structure

Structural Repair of the Galleria Parking Structure in Bismarck, North Dakota, USA

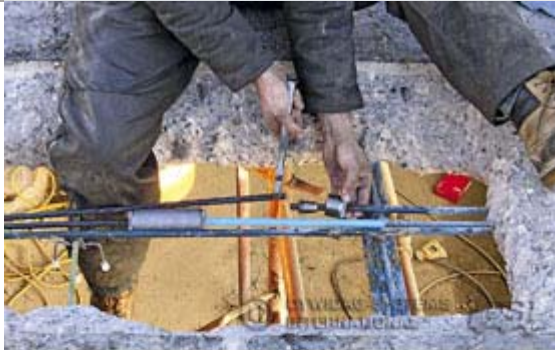
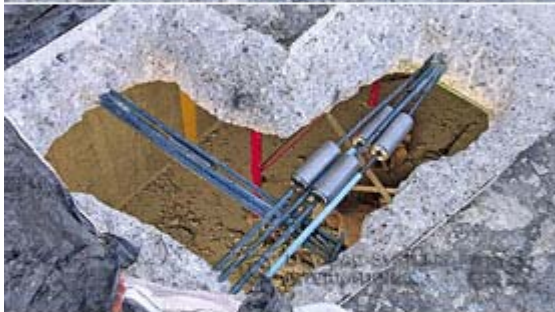
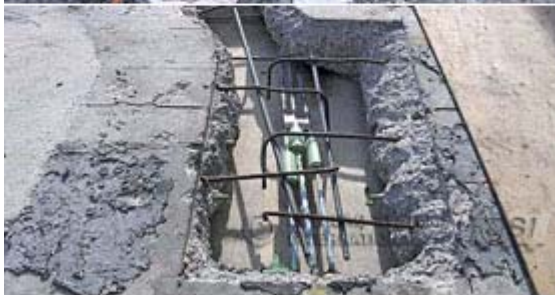
Concrete planters located on the roof terrace level had been leaking for years. Furthermore, plants had to be replaced on a regular basis because the high degree of lime in the concrete tended to damage the plants. The BPA employed a contractor to remove the planters and install a new watertight roofing system. Concrete topping below the planters was to be removed as part of the work and the contractor decided to saw cut this topping into several pieces to speed its removal. Because the topping varied in thickness to allow drainage and the contractor was not aware of the variation in thickness, several post-tensioned tendons were cut by mistake.

The structural integrity of the parking structure was severely compromised, and the structure had to be immediately stabilized with a shoring system in order to avoid possible collapse. Two of the parking levels were completely shut down, and parking at ground level was limited.

Bismarck Parking Authority commissioned the experts at DSI USA to perform comprehensive repairs of the damaged post-tensioned tendons. The severed sections of post-tensioned strands were removed and replaced with new strand. DSI USA used coupler splices and special center stressing anchorages to attach the new strand to the existing strand. Subsequently, DSI USA carried out the necessary re-tensioning of the tendons and sealed the exposed strand at the splice locations.

One of the supporting columns required special attention during the repair. Most of the top reinforcing bars were cut at this column, causing an increased concern of puncture shear failure at this location. For this special problem, the engineering company Walker Parking Consultants designed special negative moment straps that were installed by DSI USA. The straps were laid on a bed of epoxy and fastened by DSI USA using anchor bolts per Walker Parking Consultants instructions.
