**DYWIDAG Ring Tendons increase Capacity of Digester Tanks**

**External Strengthening of Digester Tanks, New Stanton, Pennsylvania, USA**

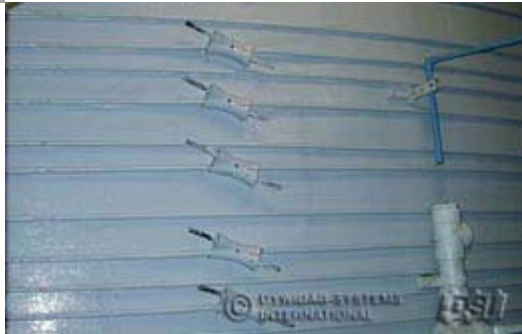
For the actual reinforcement of the walls DSI USA installed a total of 56 sheathed and greased DYWIDAG Ring Tendons 0.6" around each tank and anchored them in movable ME type couplers. The strand ends were overlappingly spliced in pairs and tensioned by means of special bent adapters. Subsequently, the DYWIDAG Ring Tendons and Couplers that had been installed on the outer walls were painted to match the color of the concrete wall.
