Repair & Strengthening

DYWIDAG Monostrand Repair Methods Save Parking Structure

Structural Repair of the Galleria Parking Structure in Bismarck, North Dakota, USA

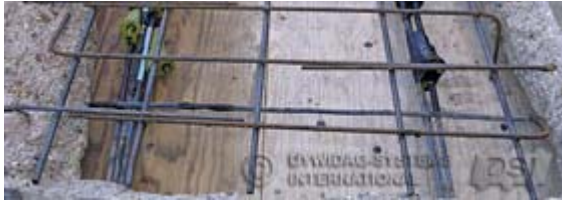
Concrete planters located on the roof terrace level had been leaking for years. Furthermore, plants had to be replaced on a regular basis because the high degree of lime in the concrete tended to damage the plants. The BPA employed a contractor to remove the planters and install a new watertight roofing system. Concrete topping below the planters was to be removed as part of the work and the contractor decided to saw cut this topping into several pieces to speed its removal. Because the topping varied in thickness to allow drainage and the contractor was not aware of the variation in thickness, several post-tensioned tendons were cut by mistake.

The structural integrity of the parking structure was severely compromised, and the structure had to be immediately stabilized with a shoring system in order to avoid possible collapse. Two of the parking levels were completely shut down, and parking at ground level was limited.

One of the supporting columns required special attention during the repair. Most of the top reinforcing bars were cut at this column, causing an increased concern of puncture shear failure at this location. For this special problem, the engineering company Walker Parking Consultants designed special negative moment straps that were installed by DSI USA. The straps were laid on a bed of epoxy and fastened by DSI USA using anchor bolts per Walker Parking Consultants instructions.

Bismarck Parking Authority commissioned the experts at DSI USA to perform comprehensive repairs of the damaged post-tensioned tendons. The severed sections of post-tensioned strands were removed and replaced with new strand. DSI USA used coupler splices and special center stressing anchorages to attach the new strand to the existing strand. Subsequently, DSI USA carried out the necessary re-tensioning of the tendons and sealed the exposed strand at the splice locations.
