## Slope Stabilization

## Via Estoril slope stabilization, Laguna Niguel, California, USA

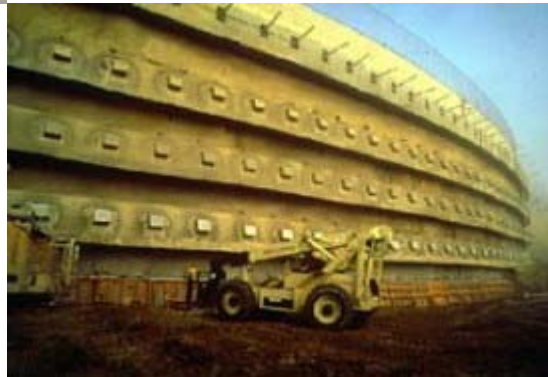
Heavy rains produced A 150m long slide that destroyed several hilltop homes. The project design incorporated a 117m long wall made from circular reinforced concrete caissons with steel pile cores inserted deep into the soil.

Concrete grade beams tied the system together.

A total of 242 pieces DYWIDAG multistrand anchors 9-0.6" with double corrosion protection were anchored back into reinforced concrete grade beams and caissons.
